## SCENARIOS FOR DEALING WITH THE FAILED DAM ON PINE LAKE

## Scenario 1: *Status quo*, riverside meadow

## Scenario 2: Remove the old dam, ± create a riverside park

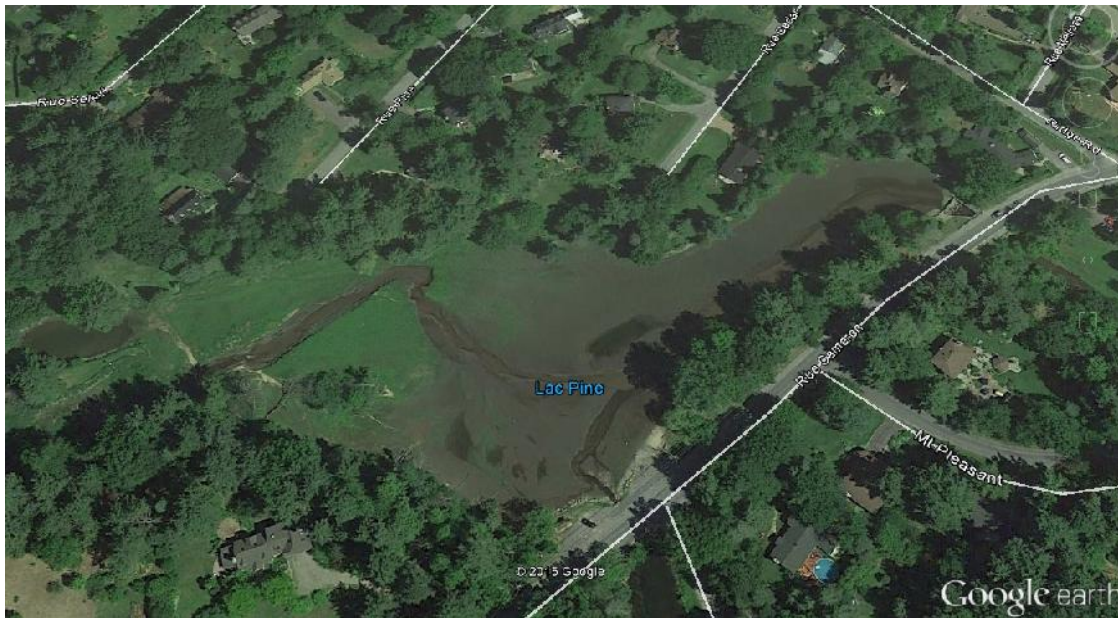
**Figure 1.** Pine Lake basin on 18 June 2014, two months after the dam failed. During summer 2014 the lake bed was colonized by meadow grasses and wildflowers, which persisted in 2015. The damaged dam is in place, and flood waters have partially and temporarily refilled the lake basin during intense rainstorms in 2014 and 2015.

Note that the Viviry River flows through the drained lakebed and a major tributary (Black Creek) flows under Cameron Road into the lake basin to join the Viviry just upstream of the present dam site. This is noteworthy because the Black Creek sub-basin accounts for 30% of the Viviry River watershed, which significantly increases the amount of floodwater reaching the present dam site. In consideration of ongoing climate change this is worrisome in that only 27% of the Black Creek drainage basin is in Hudson -- we do not control land development in the other 73% of the sub-basin that lies in St-Lazare and Vaudreuil-Dorion. Runoff and sedimentation into Black Creek will increase as land is developed in the sub-basin. Hence flood risk is likely to increase in future.

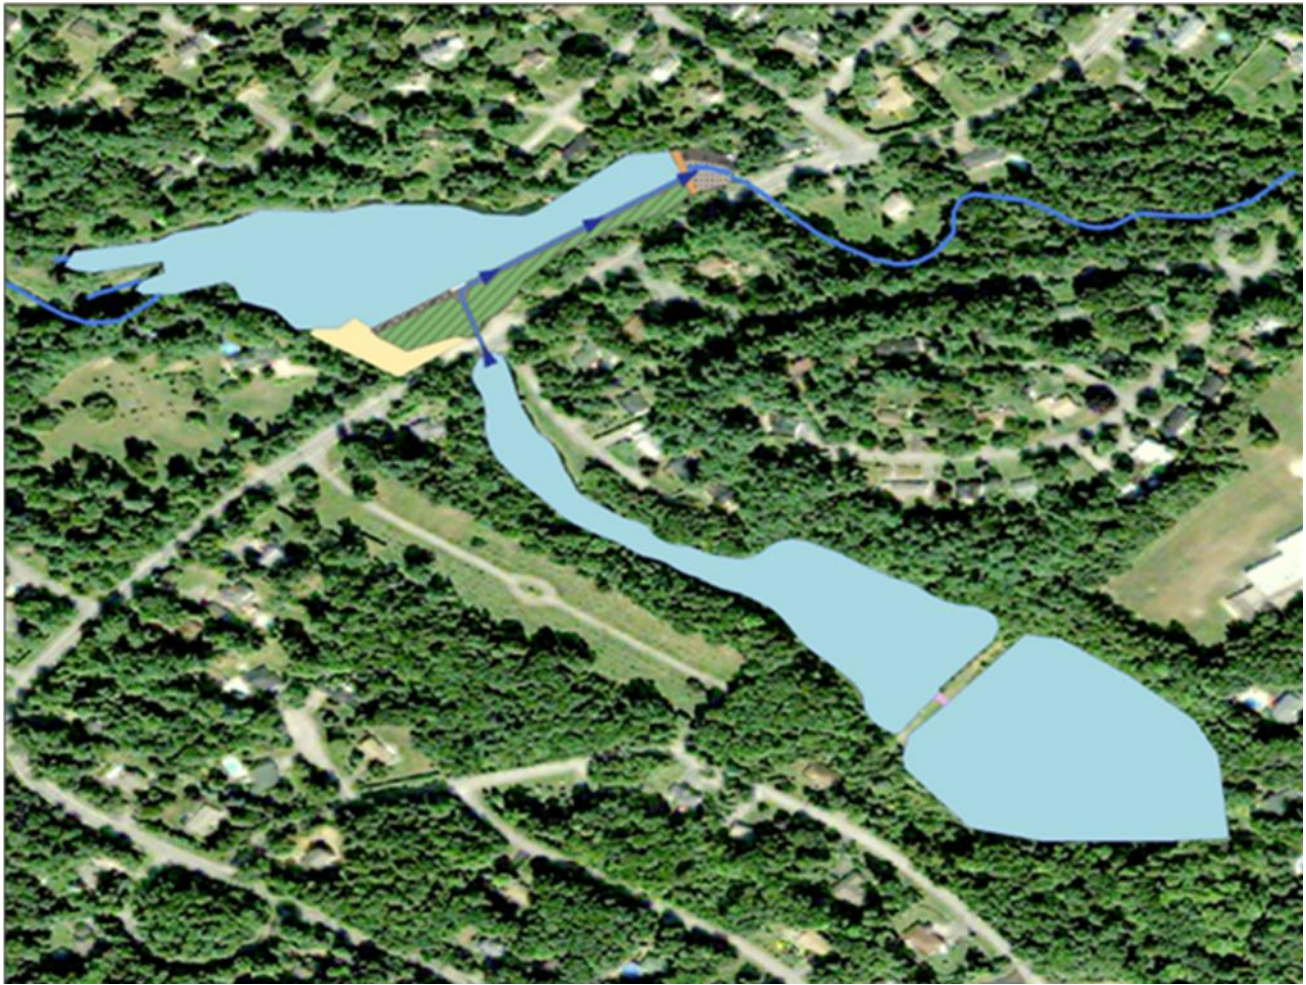
**Figure 8b.** The lower reach of Black Creek as an auxiliary retention basin. During major floods the town could open the overflow gate in the side of the Black Creek culvert to let water drain from the lake to reduce the risk of the dam failing. Lake water would then flow through the Black Creek culvert into the Viviry below the dam and also spill upstream in Black Creek to flood the marshy areas associated with the Driscoll-Naylor Bird Sanctuary. Periodic flooding would be advantageous to the marsh vegetation and provide temporary flood retention capacity without risk to residential properties.

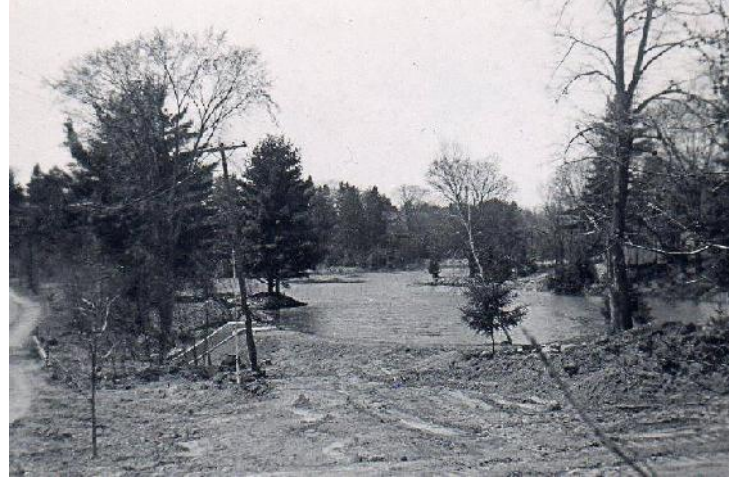
**#2** Pine Lake in 1947 – Unpaved Cameron Rd to the far left is below present grade, and the earthen dam to the right of the spillway clearly visible. Cynthia Maher's property not yet developed at this time. (MH)

EXP did not specifically show the placement or design of their earthen dam, which could take many forms. One possible design essentially replicates the original dam built in 1946 (c.f. photos #1 and #2 in Appendix 1): an earthen dam parallel to Cameron Road. The 1946 dam had a concrete spillway at the site of the 1990 dam, with the lake water level controlled simply by insertion of barriers into slots in the spillway walls. This design requires the sill of the spillway to be below the present level of Cameron Road at the Black Creek culvert, which we believe unduly restricts the possibility of optimizing the design of an earthen dam relative to present and future flood risks. We subsequently present scenario 6 as a variant on this alternative that secures greater flood control by diverting the flow of Black Creek.

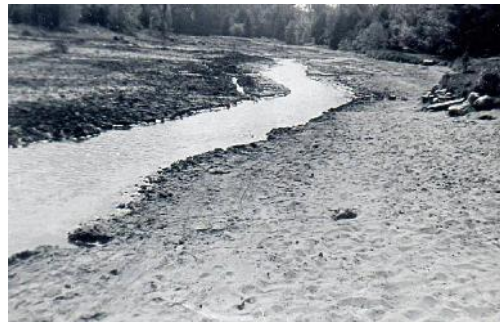
**#3** Pine Lake was drained in 1957 to dredge a 60 x 200 foot 'swimming hole', 10 feet deep, and about 40 feet off the beach along Cameron Road. (MH)

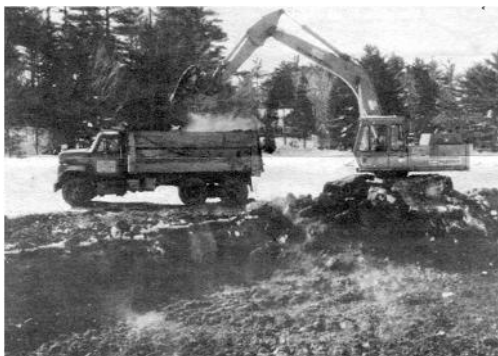
**#5** The lake bed was dredged in winter 1987, three years after the town took responsibility for Pine Lake. In 1984 it had been estimated that 15,000 yds<sup>3</sup> of sediment needed to be removed. (MH)
